Estimated Cost of Repairing Road Pavement Damage Assessment: A Case Study of Indonesia

Edy Suhartono, Muhammad A, Renggananda BP, Martono, Marsudi

Department of Civil Engineering

State Polytechnic of Semarang

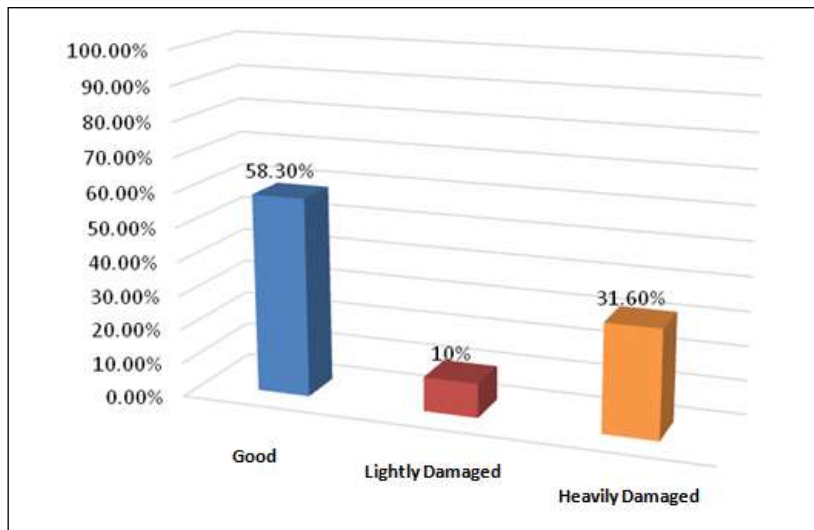
3.1 Conditions of Pavement Based on the basic conditions of the Letjend DI Panjaitan route after assessment of road conditions with the Margin Development Method is obtained as follows:

Fig 1. Graph of Pavement Conditions in Jalan Pematang - Randudongkal
(Source: Field Research Results (2018))

1. Based on the analysis of the level of damage to road conditions according to Bina Marga Standards is 58.30% (good), 10% (small damage), and 31.60% (heavy damage);
2. To repair damaged and lightly damaged roads, repairs are needed with the 1995 Bina Marga Standard Improvement Method, while for the repair of heavily damaged roads, rigid pavements with 25 cm pavement thickness are needed.
3. Repair costs are Rp. 2,880,928,554.00 more economical 72.57% compared to the calculation of Bina Marga Standards using overall pavement repairs.
