# Seismic Performance Evaluation of Existing Reinforced Concrete Buildings in Yangon

## ABSTRACT

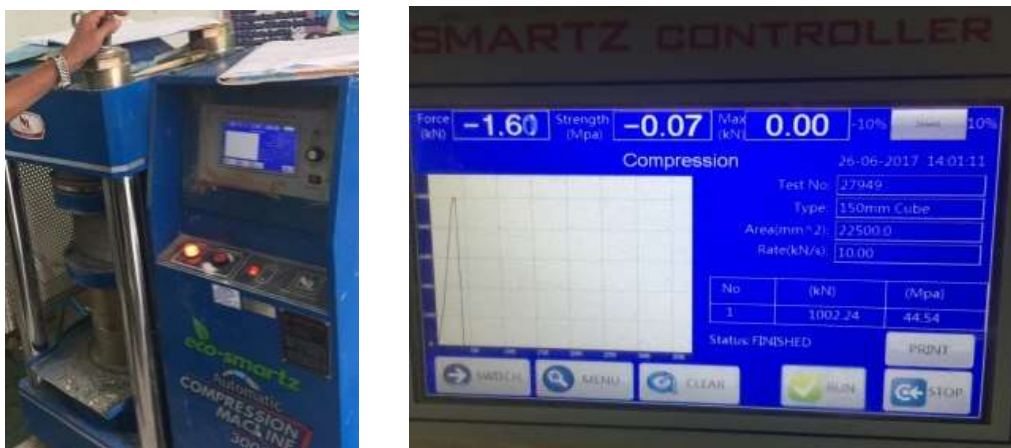
Fig. 1 (a) Compressive machine and Data recording

The calibration of the rebound hammer is done by compressive machine test data as shown in Fig.1 The results obtained from the rebound value of the tube mould and the actual compressive strength obtained from the compressive machine is graphed to get the correlated equation as shown in Fig 2.

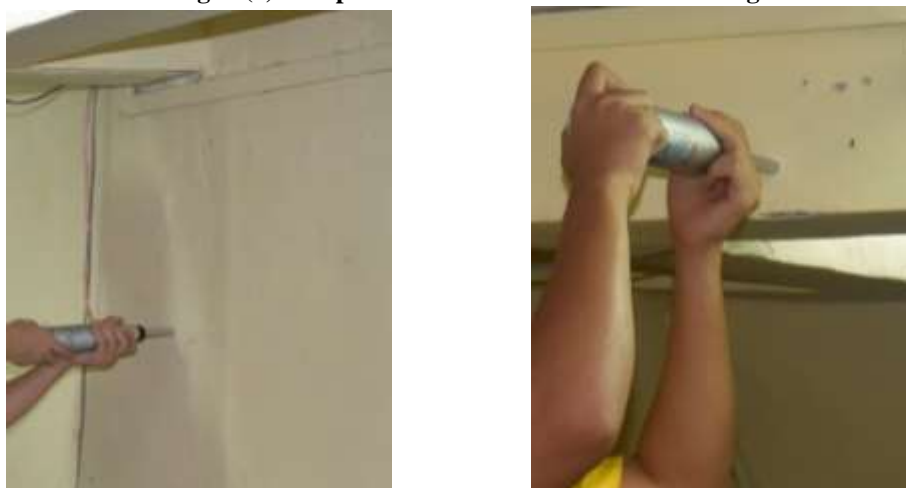
Figure 2. (b) Test by Rebound Hammer on Existing Members

The concrete condition of the existing R.C buildings are then tested using rebound hammer. From the test results, the following data can be obtained as in Table 5.

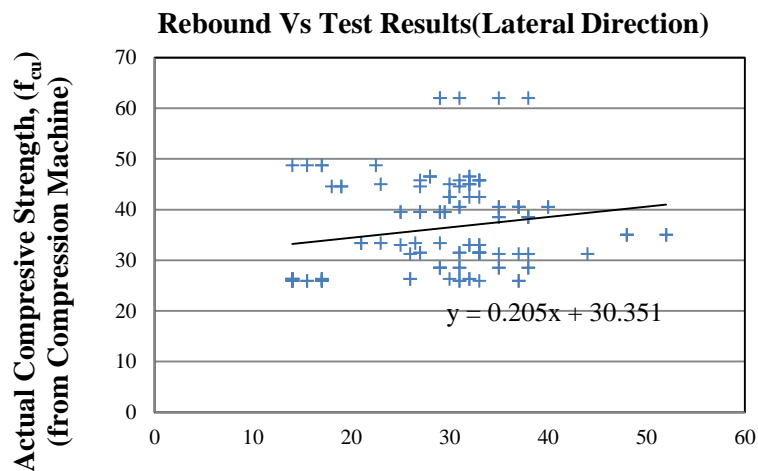
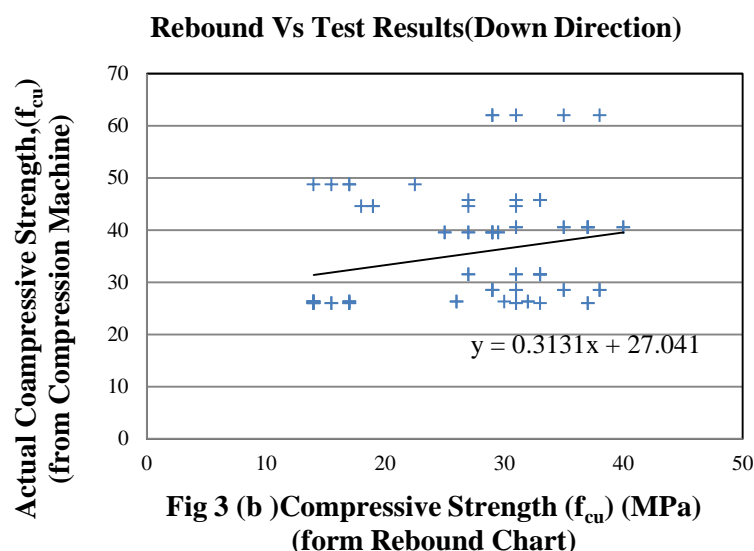
**Fig. 2 Calibrated Graphs for Rebound Hammer (a) Lateral Direction (b) Down Direction**

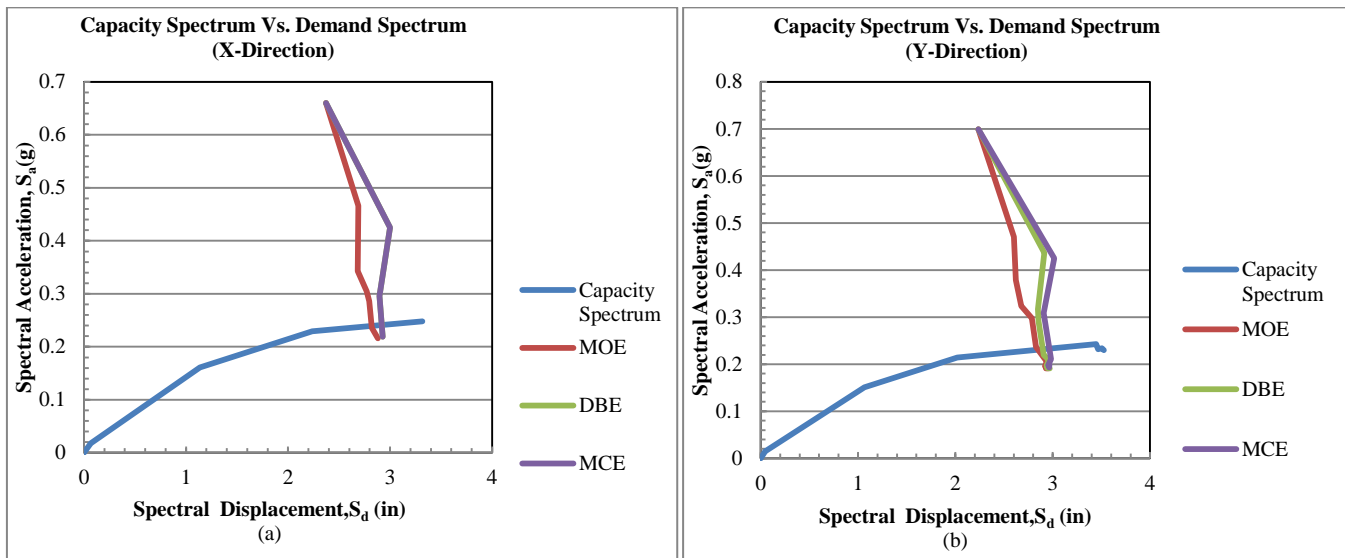
Fig. 3 Pushover Curve for 3 story R.C Building (a) X-direction (b) Y-direction

Results of the Push-Over analysis are presented in Fig 3, 4 and 5. (push-over curves, in each of the 2 main directions). The performance point at the intersection of the capacity spectrum with the single demand spectrum for different levels of shaking (MOE, DBE and MCE) has been obtained.

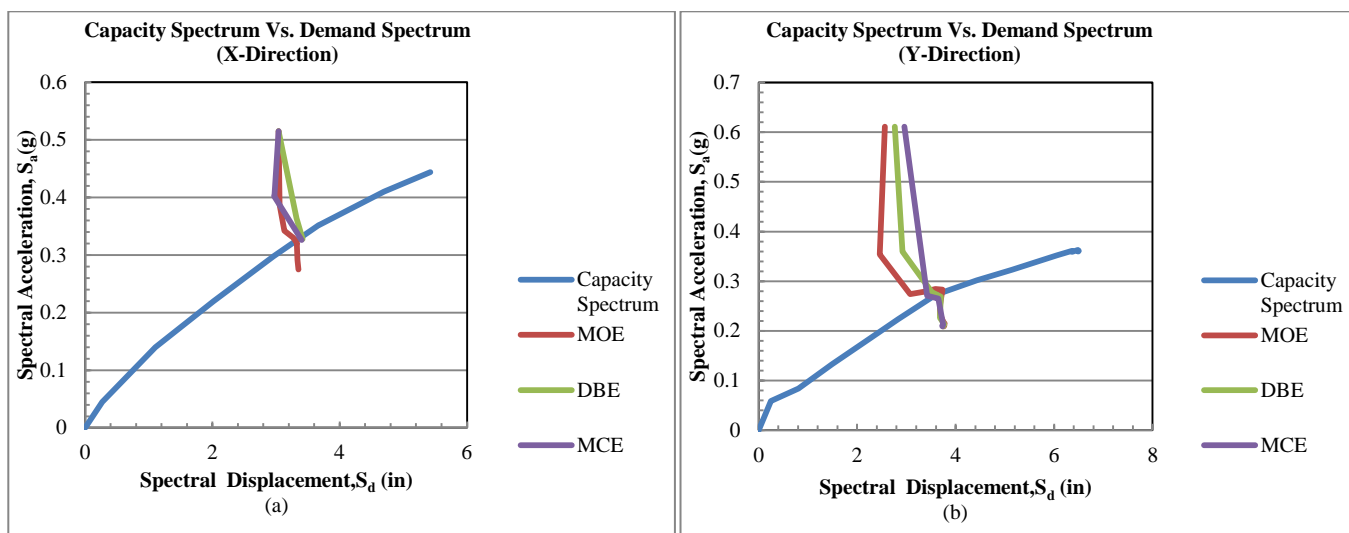
Fig. 4 Pushover Curve for 6 story R.C Building (a) X-direction (b) Y-direction

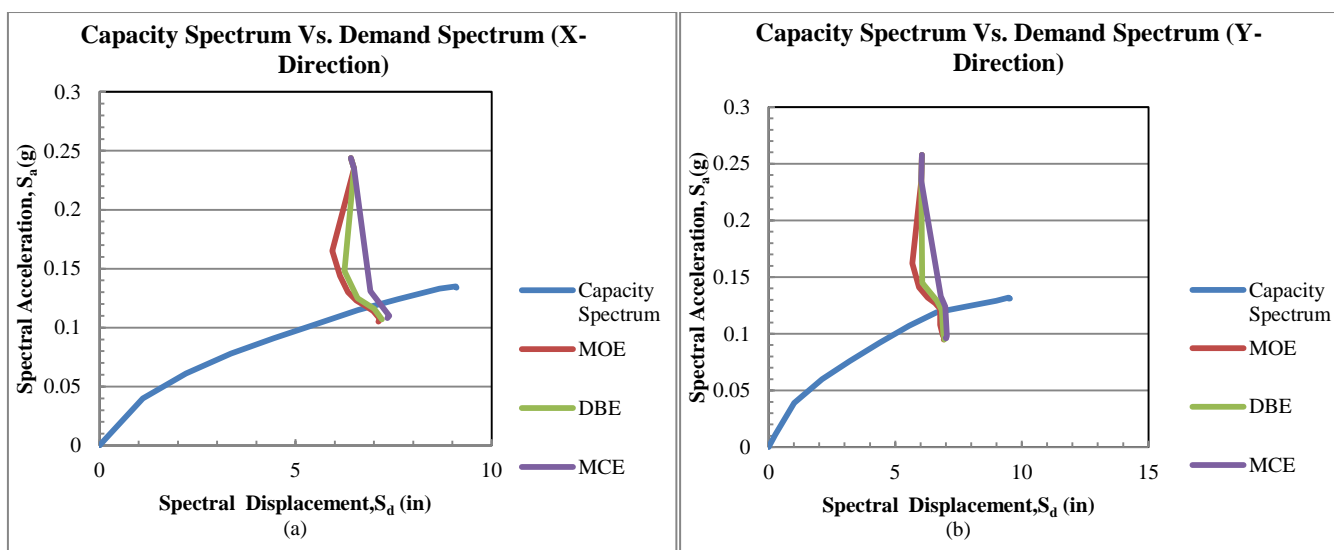
Fig. 5 Pushover Curve for 8 story R.C Building (a) X-direction (b) Y-direction

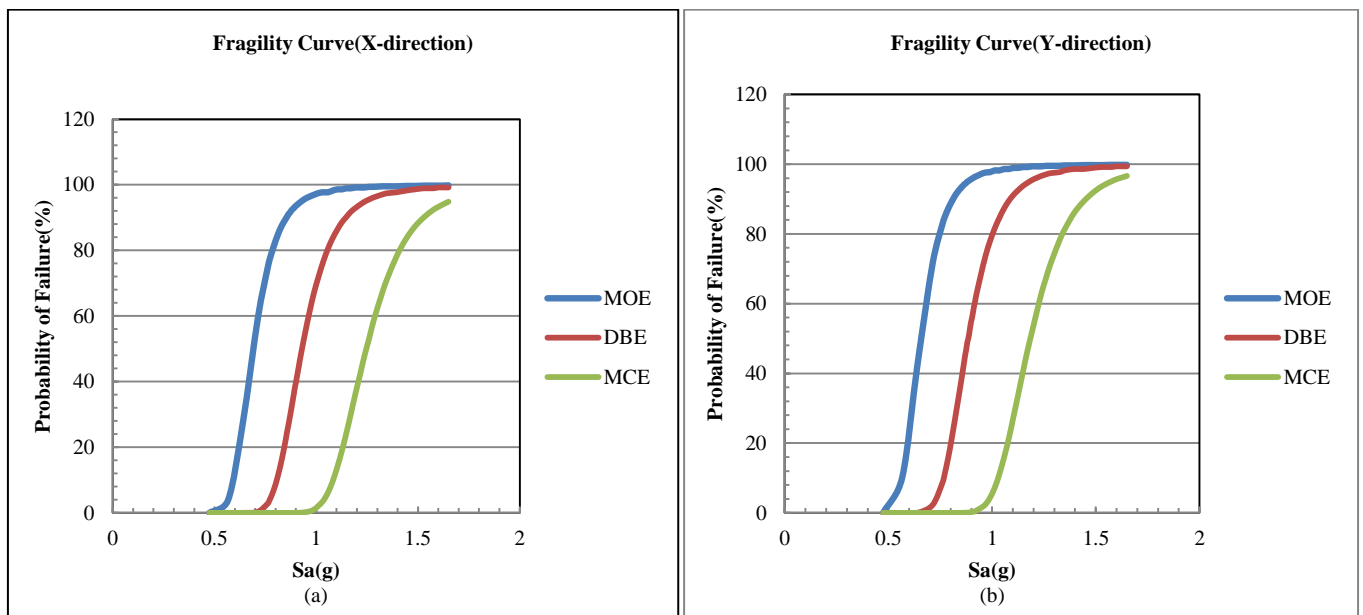
**Fig. 6 Fragility Curve for 3 story R.C Building (a) X-direction (b) Y-direction**

According to the fragility curve of 3 story R.C Building, it is in the 59.6% immediate occupancy damage state due to the spectral acceleration of 0.743 g excitation for MOE. The building is in the 22.36% failure of life safety state due to 0.85g for DBE and 93.4% will collapse for MCE with 1.65g excitation.

The fragility analysis is done base on the spectral displacement of analysis of each of the buildings. The fragility curve is drawn for each level of earthquake and the probability of failure is obtained based on this fragility curve as in Fig 6, 7 and 8. From these fragility curves,

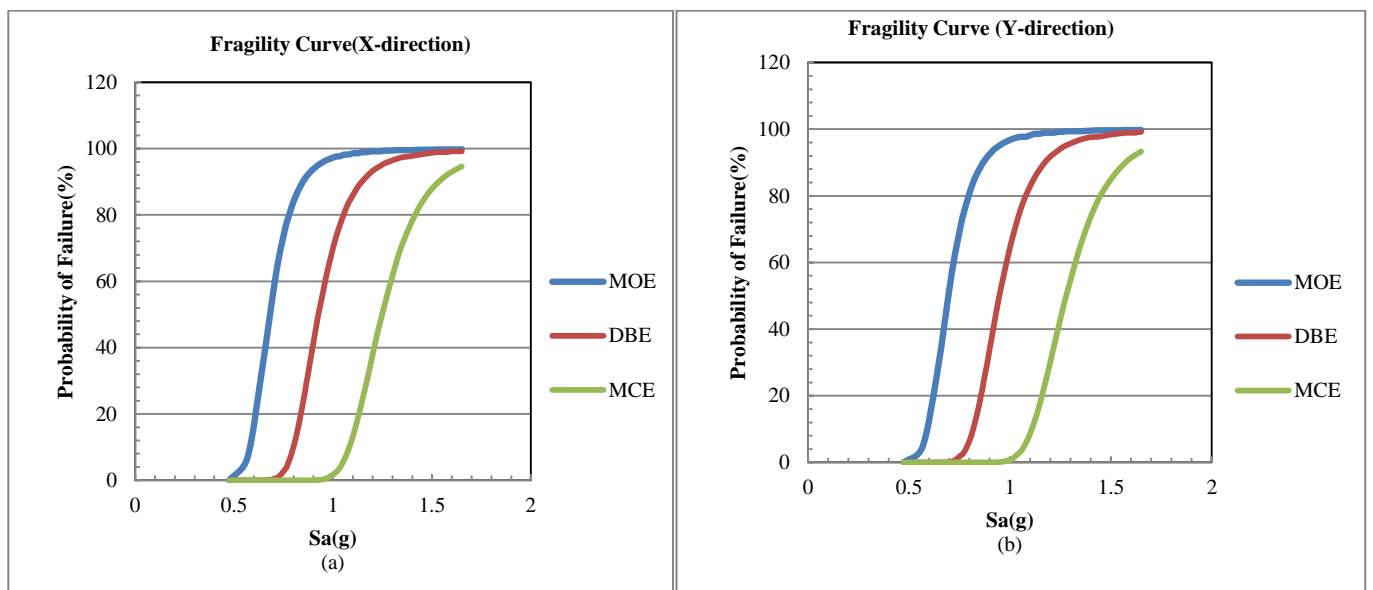
**Fig. 7 Fragility Curve for 6 story R.C Building (a) X-direction (b) Y-direction**

According to the fragility curve of 6 story R.C Building, it is in the 33.56% immediate occupancy damage state due to the spectral acceleration of 0.645 g excitation for MOE. The building is in the 24.21% failure of life safety state due to 0.81g for DBE and 92.2% will collapse for MCE with 1.65g excitation.

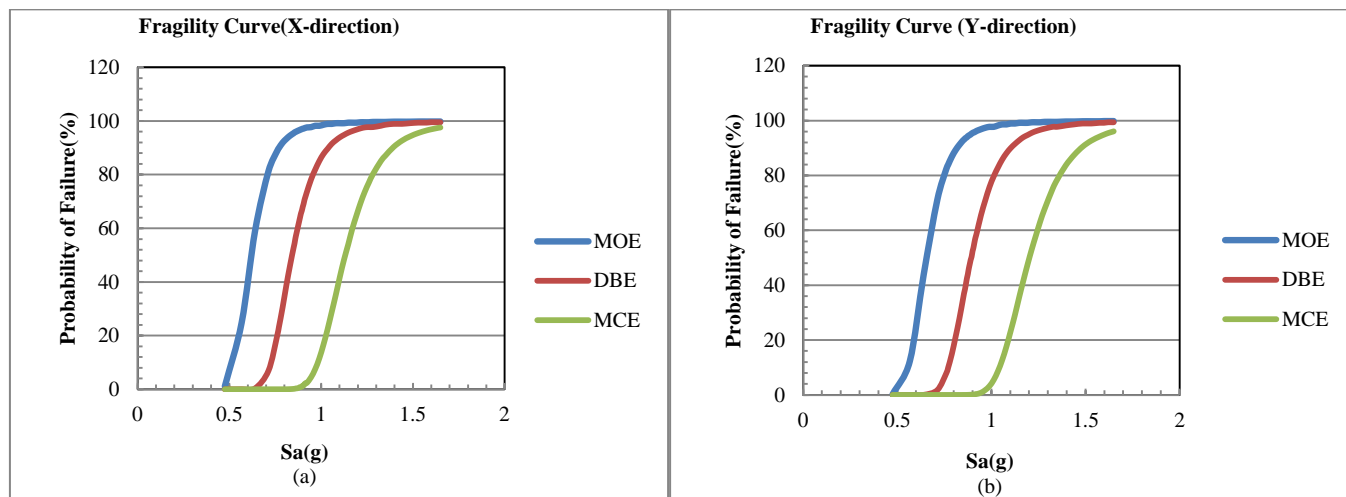
**Fig. 8 Fragility Curve for 8 story R.C Building (a) X-direction (b) Y-direction**

According to the fragility curve of 8.5 story R.C Building, it is in the 48.6% immediate occupancy damage state due to the spectral acceleration of 0.74 g excitation for MOE. The building is in the 26.36% failure of life safety state due to 0.85 g for DBE and 95.45% will collapse for MCE with 1.65g excitation.
